DESIGN OF FLEXIBLE AIRFIELD PAVEMENTS FOR  
MULTIPLE-WHEEL LANDING GEAR ASSEMBLIES

TEST SECTION WITH LEAN CLAY SUBGRADE

TECHNICAL MEMORANDUM NO. 3-349

WATERWAYS EXPERIMENT STATION

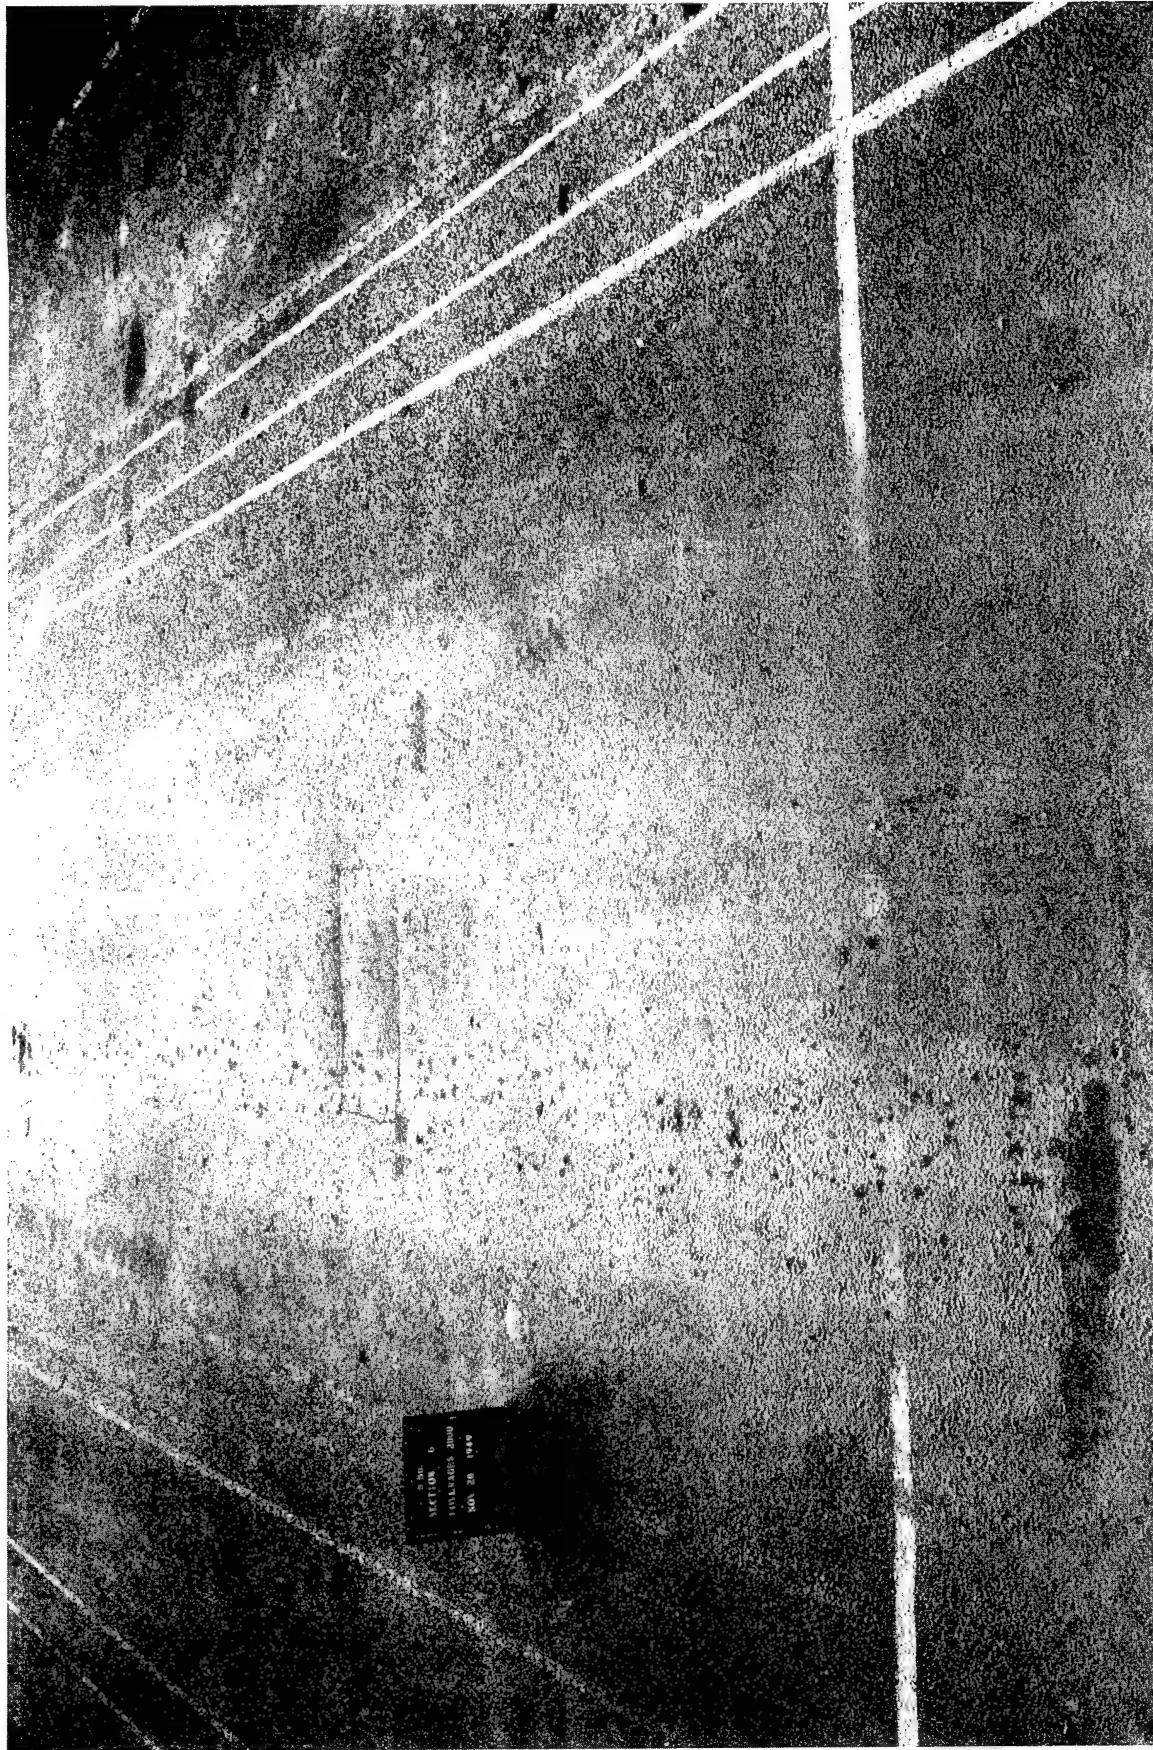
Photograph 20. Unit 6, 20-in. thickness. View showing condition of pavement after 2,000 coverages with 100,000-lb load on B-50 assembly
